## Quick installation in the Konotopa channel

### Weholite guaranteed a simple and quick installation in the Konotopa channel

Location	Anno di completamento
Warsaw, Poland	2016
Tipologia di edificio	Product systems
Comune	Drenaggio, Costruzioni su misura
Tipologia progetto	
Nuovo edificio

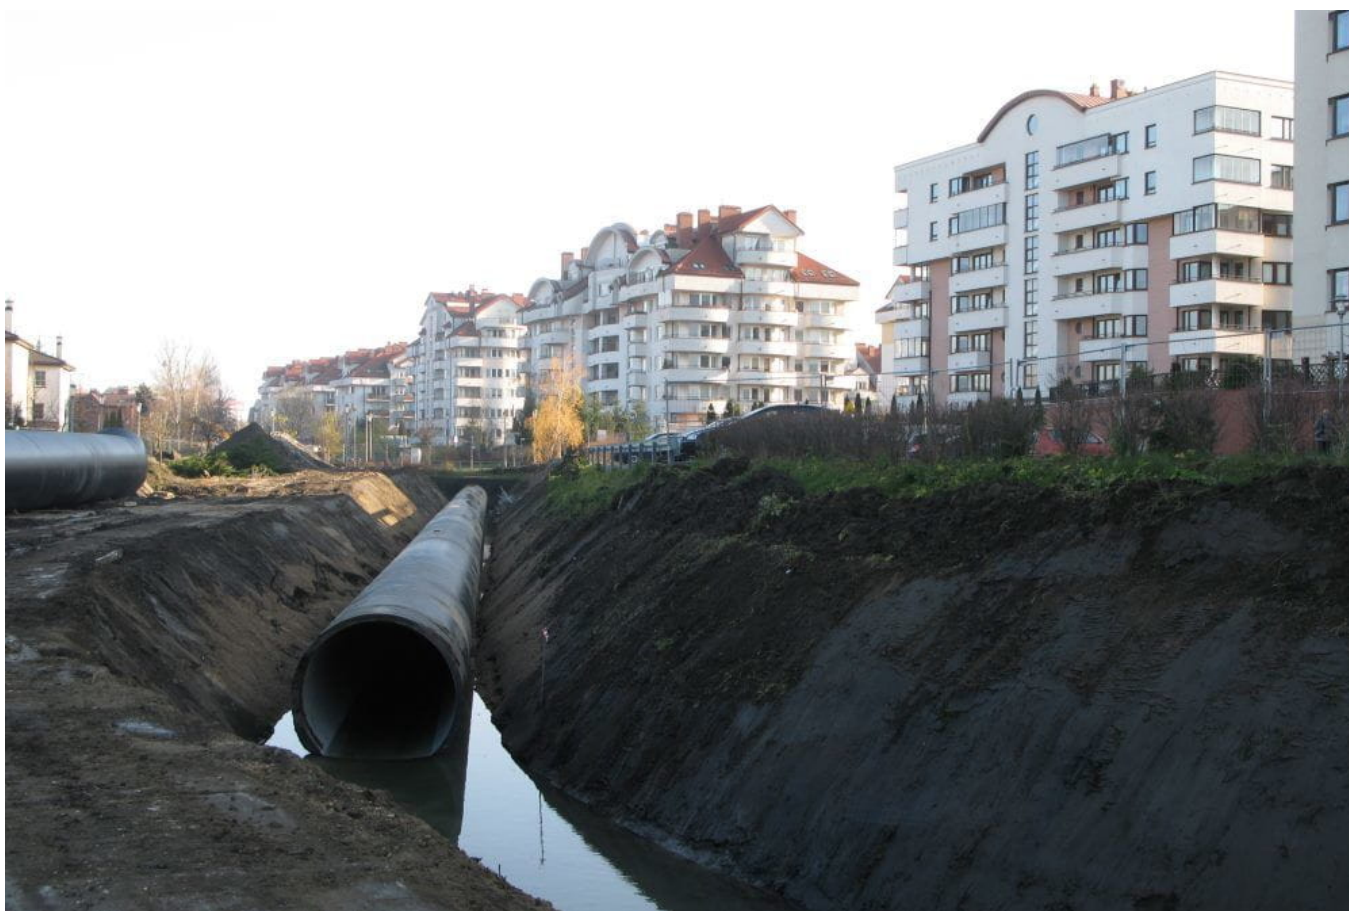
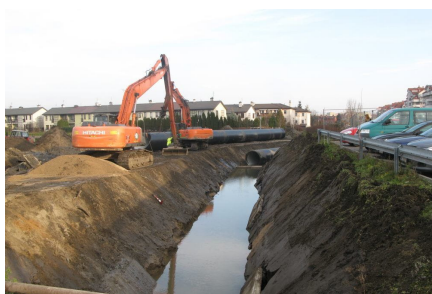
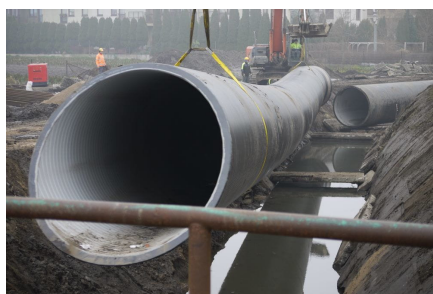
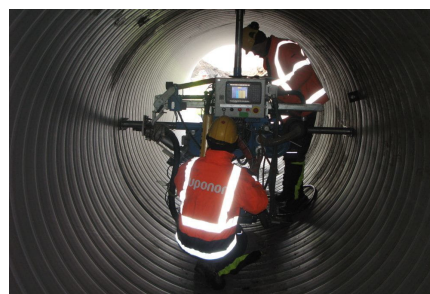
### Weholite guaranteed a simple and quick installation in the Konotopa channel

Following a tender, in September 2016 Drainage Construction Company Tolos was appointed as the general contractor for the project. Uponor Infra delivered a total of 165 metres of structured-wall PE-HD Weholite, DN/ID 2,000mm SN4 pipes to the installation site. Prep work included clearing the channel of concrete slab lining, dredging the ditch to make room for the new pipeline and laying the bedding. Uponor Infra pipe service staff then joined up the Weholite pipes to form two sections. The work was carried out on dry land on the right bank of the channel, by means of automatic extrusion welding using a WLI- 3000 machine. This guaranteed the 100% tightness and homogeneity of the pipeline. A 100- metre section of pipeline was then lowered into the ditch, followed by the remaining 50-metre section with a fitted bend two days later. Since the channel was operational during installation, the two connecting sections of the pipeline were raised above the water level, where they were welded together. The pipeline was then connected to a reinforced concrete inlet of the underground section of the channel. A socket- and- spigot DN/ID200mm joint was fitted onto the pipeline, connecting it to an existing stormwater channel. Finally, the ditch was backfilled. At the spot where the new pipeline meets the open section of the channel, an outlet was secured with a steel grate to prevent unauthorised entry. The installation was completed in December 2016.
